Stacking Up

A maintenance program for chimneys is necessary to help schools avoid costly repairs later.

By Jim Naylor

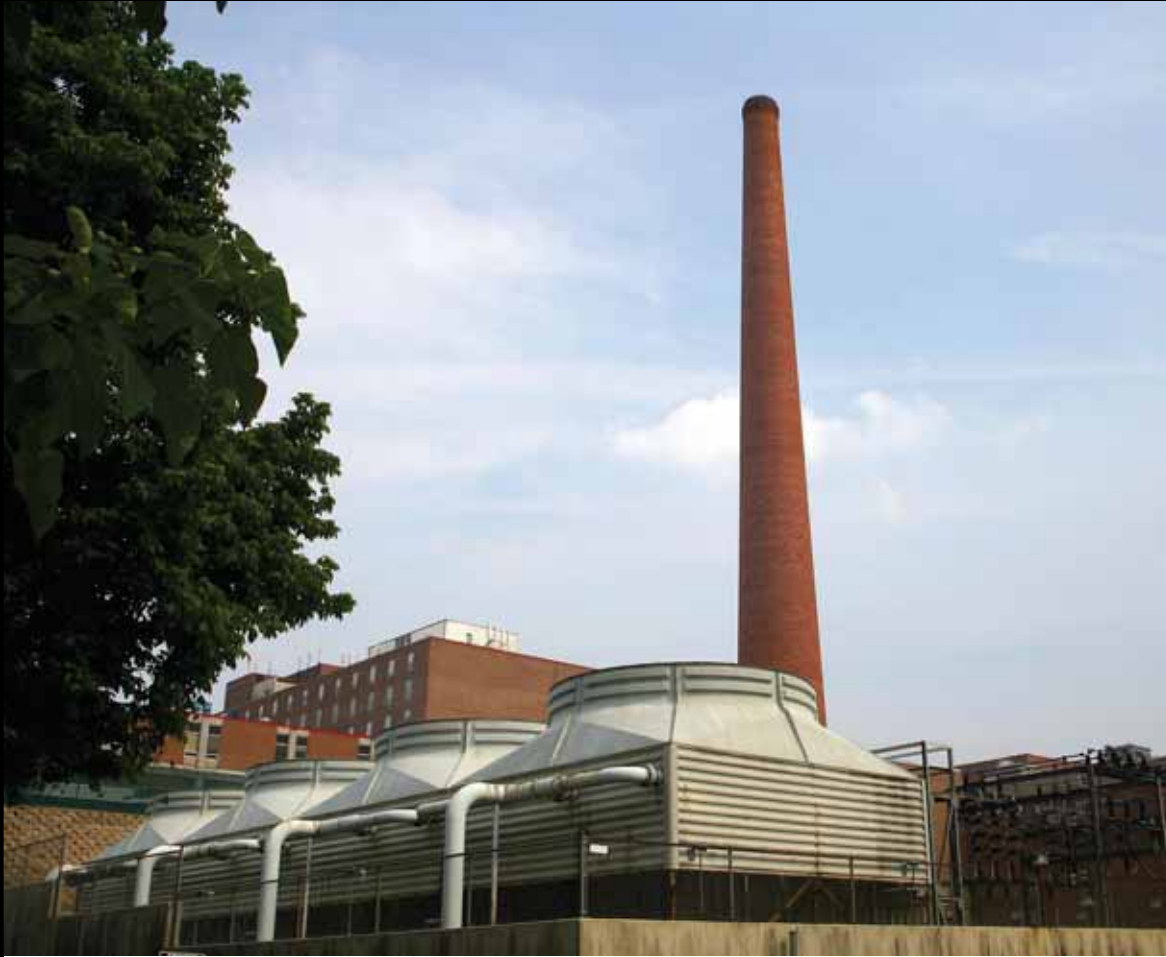
Education institutions can decrease overall chimney repairs by focusing on life-cycle costs instead of short-term maintenance and by establishing a comprehensive preventive-maintenance program.

Photo courtesy of Chad Prior/Structural Group
